Phase Imbalance Problem Solved at College Student Center

OMNI TECH TALK: Bearing Current & Shaft Voltage in VFDs

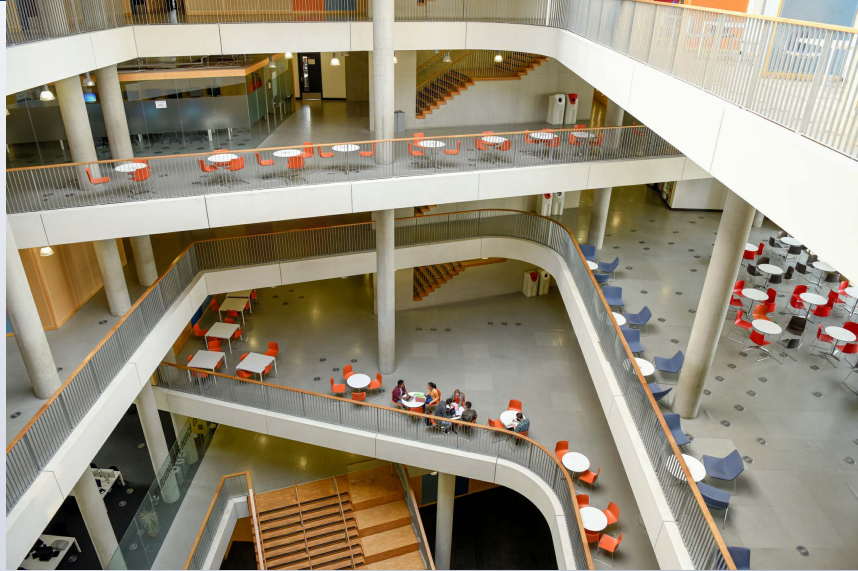
A northern New Jersey university was experiencing frequent electrical problems that were becoming very troublesome in one of its campus buildings, a six-year-old, four-story, 125,000 sq. ft. building that housed a large, open student center with cafeteria and several retail shops. Electronic distribution breakers were randomly tripping, turning off power and highly inconveniencing users and students. Omni Electrical & Instrumentation, Inc. was called in to diagnose and correct the issues.

Our technicians' first action was to record voltages across various parts of the system, from phase to phase and phase to ground, finding them within 1-2.5%. Amperage readings, however, taken in different parts of the building at different times of day, clearly showed an imbalance. Phases A and B were within 1-2% of each other, but the C leg was carrying at least 10% more current than the other two, causing the electronic breakers to fault or trip to protect the circuit.

Next, we set out to find where the amperage phase imbalance was occurring. Working on off-hours, our technicians started from the top down, shutting off distribution and panel breakers one by one to see where the imbalance would point. Issues were found with distribution of the lighting load across phases, providing only a partial solution.

The main culprit was discovered in the mechanical penthouses when shutting off the breaker to the large HVACR packaged chillers immediately corrected the imbalance. The problem was narrowed down to a single faulty chiller that was promptly isolated and locked out, and the manufacturer was brought in to address electrical problems in the equipment. The Student Center was quickly back in business, and the client highly satisfied with our service.

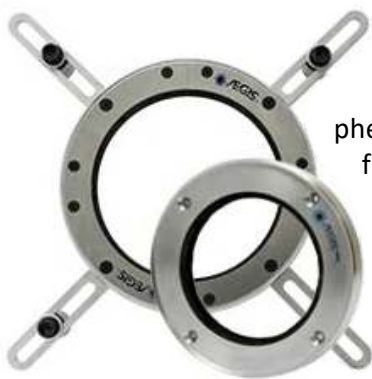
Bearing currents and shaft voltage occur in VFDs when voltage pulses couple from a motor's stator to its rotor. When this voltage exceeds the insulating capacity of the bearing grease, voltage arcs or electrical discharge machining can occur, damaging bearings and causing premature motor failure. Voltage-damaged bearings will show frosting, fluting or pitting of the bearing race surfaces. Shaft voltage can cause damage to bearings in as little as one week.

Shaft voltage discharge can be measured using a shaft voltage probe and a shaft voltage tester. One of the best ways to reduce VFD-induced shaft voltage is to install a shaft grounding ring, which conducts voltage discharge currents away from the bearings to ground. A grounding brush is another economical way to provide a low-impedance path to ground, but these devices are subject to a number of drawbacks including excessive wear, contamination and oxidation buildup. Nonconductive ceramic bearings are fairly effective but costly. Insulated bearings are costly, as well, and may not prevent bearing damage in all cases.
